Austin Transit Partnership

Lady Bird Lake Bridge Project

*Aquatic Resources Delineation Report
and Proposed Jurisdictional Analysis*

Austin, TX
January 13, 2025

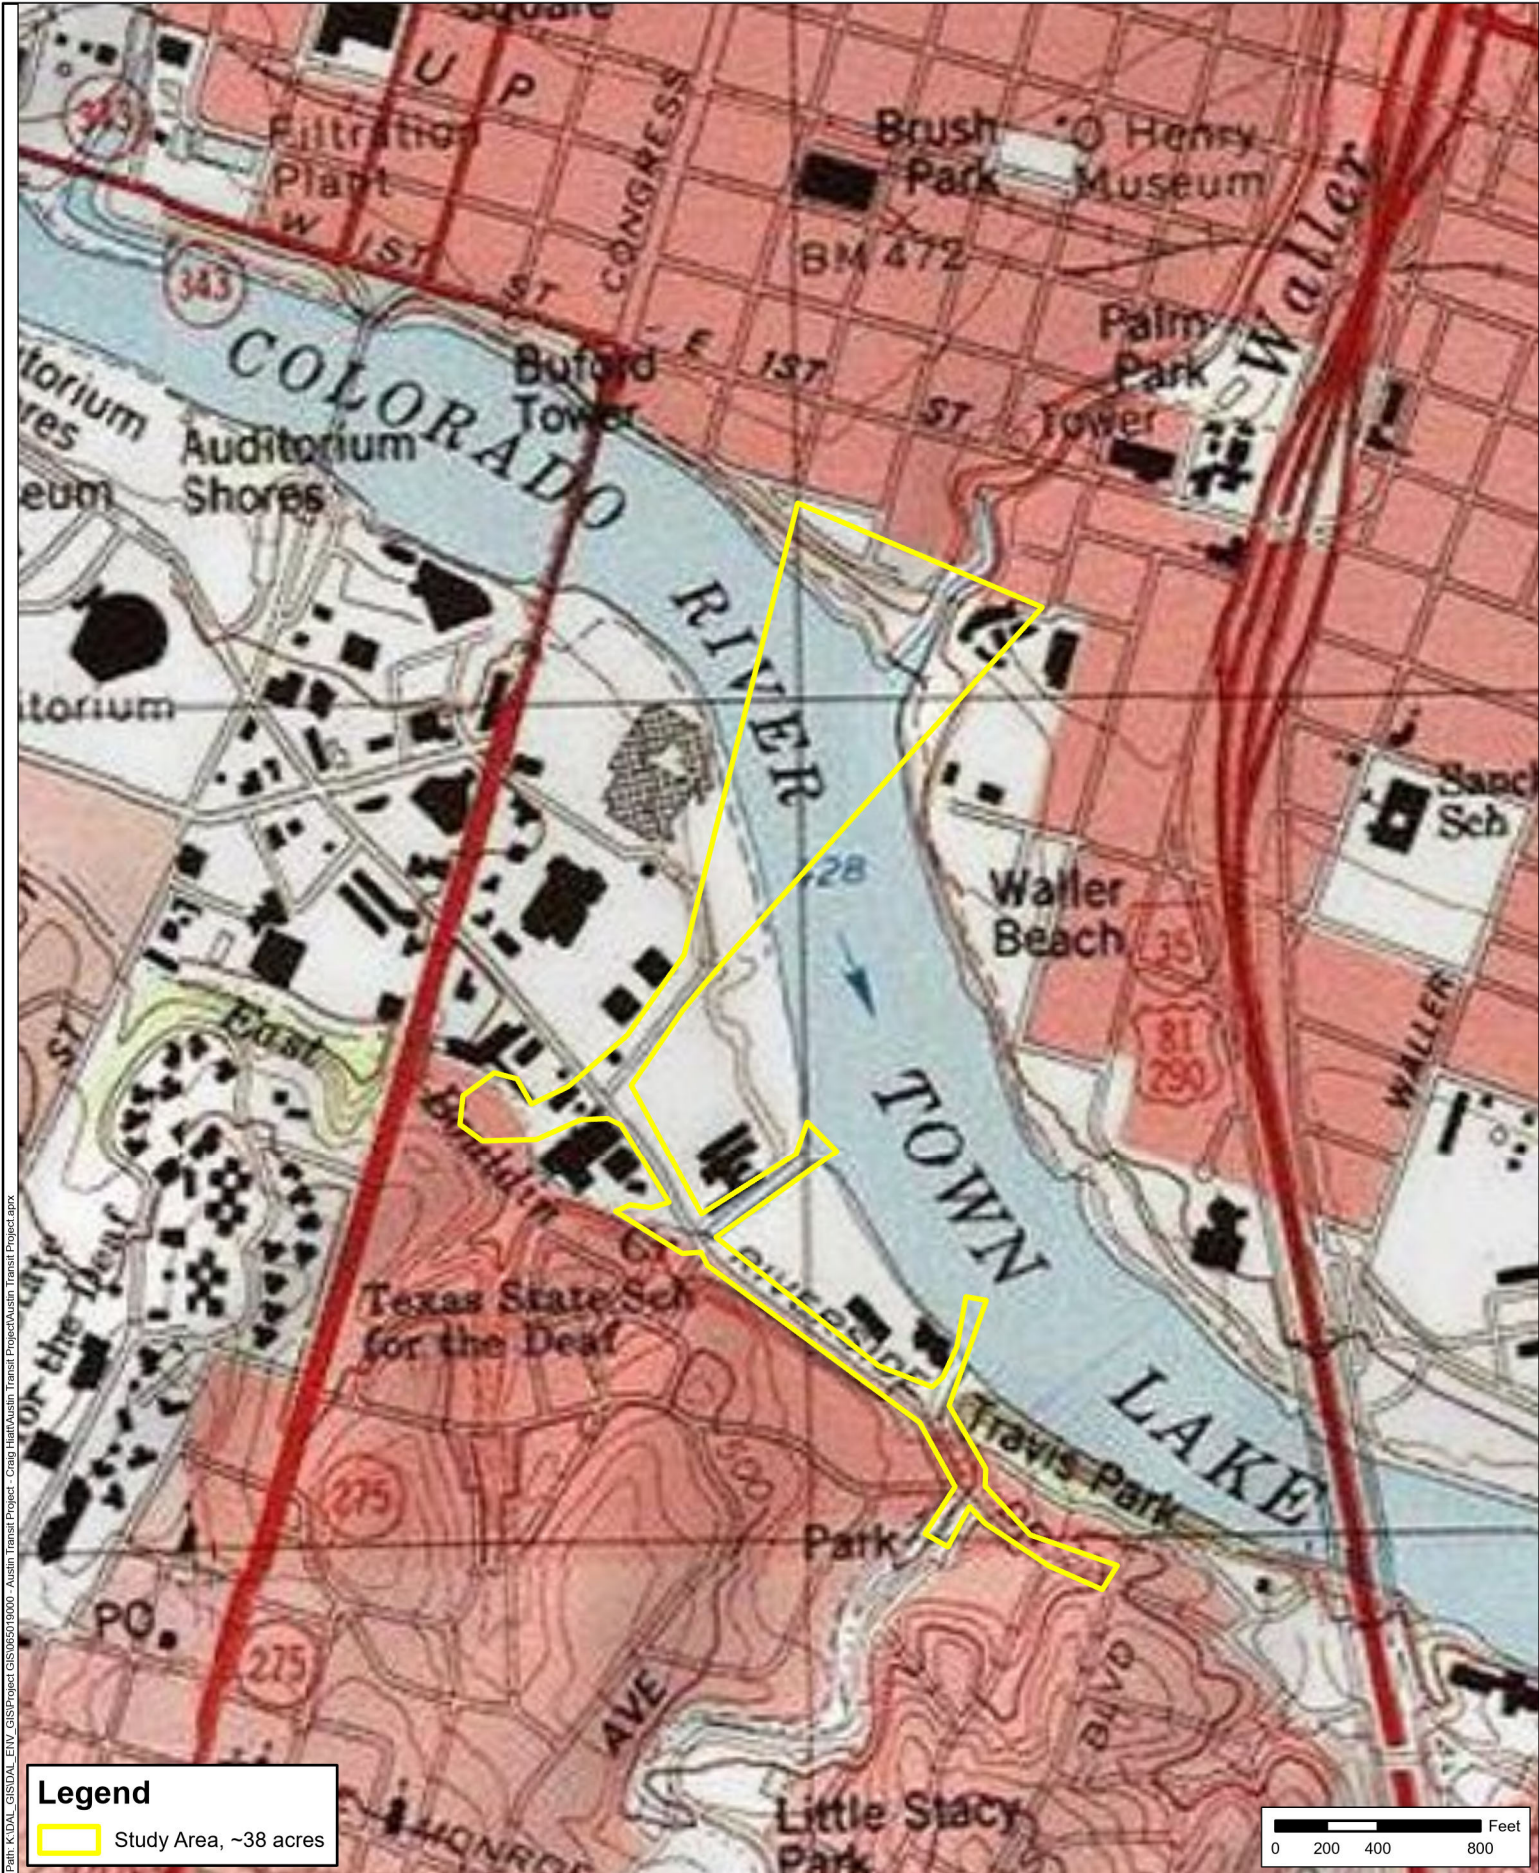
- Figure 1: Vicinity Map
 - Displays general location of the study area.
- Figure 2: United States Geological Survey (USGS) Topographic Map.
 - Depicts potential aquatic features and elevation contour lines.

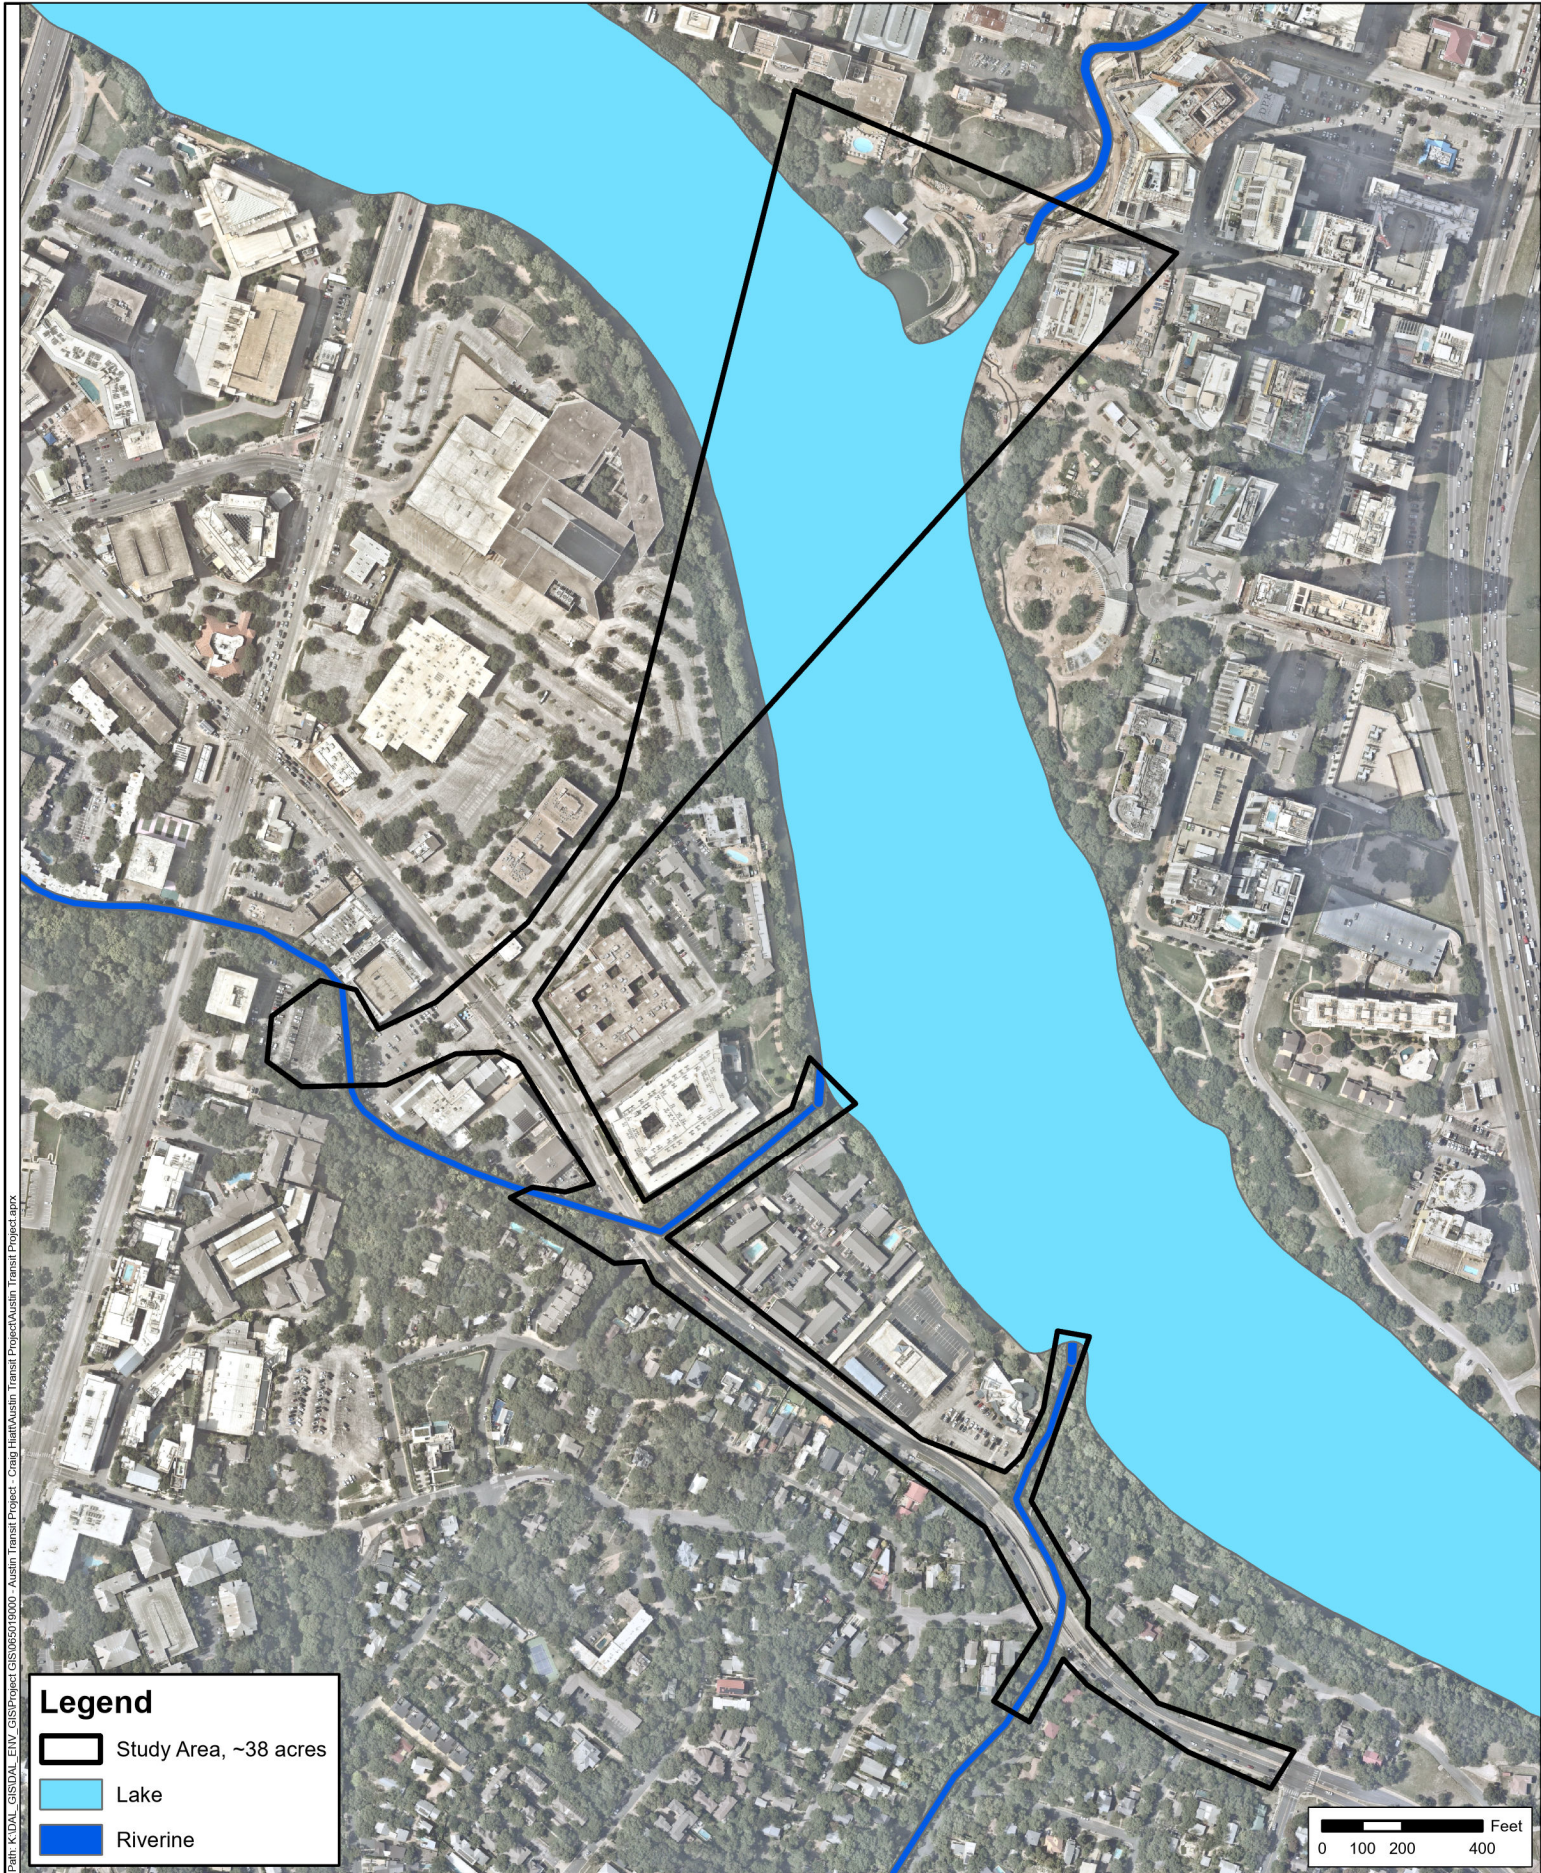
- Figure 8: National Wetlands Inventory Map
 - The U.S. Fish and Wildlife Service (USFWS) National Wetlands Inventory (NWI) online mapper was used to generate this map.

- The NWI dataset can be useful in identifying the potential presence of aquatic features.
- However, the dataset is not always accurate because it was created at coarse scale and has not been field verified.

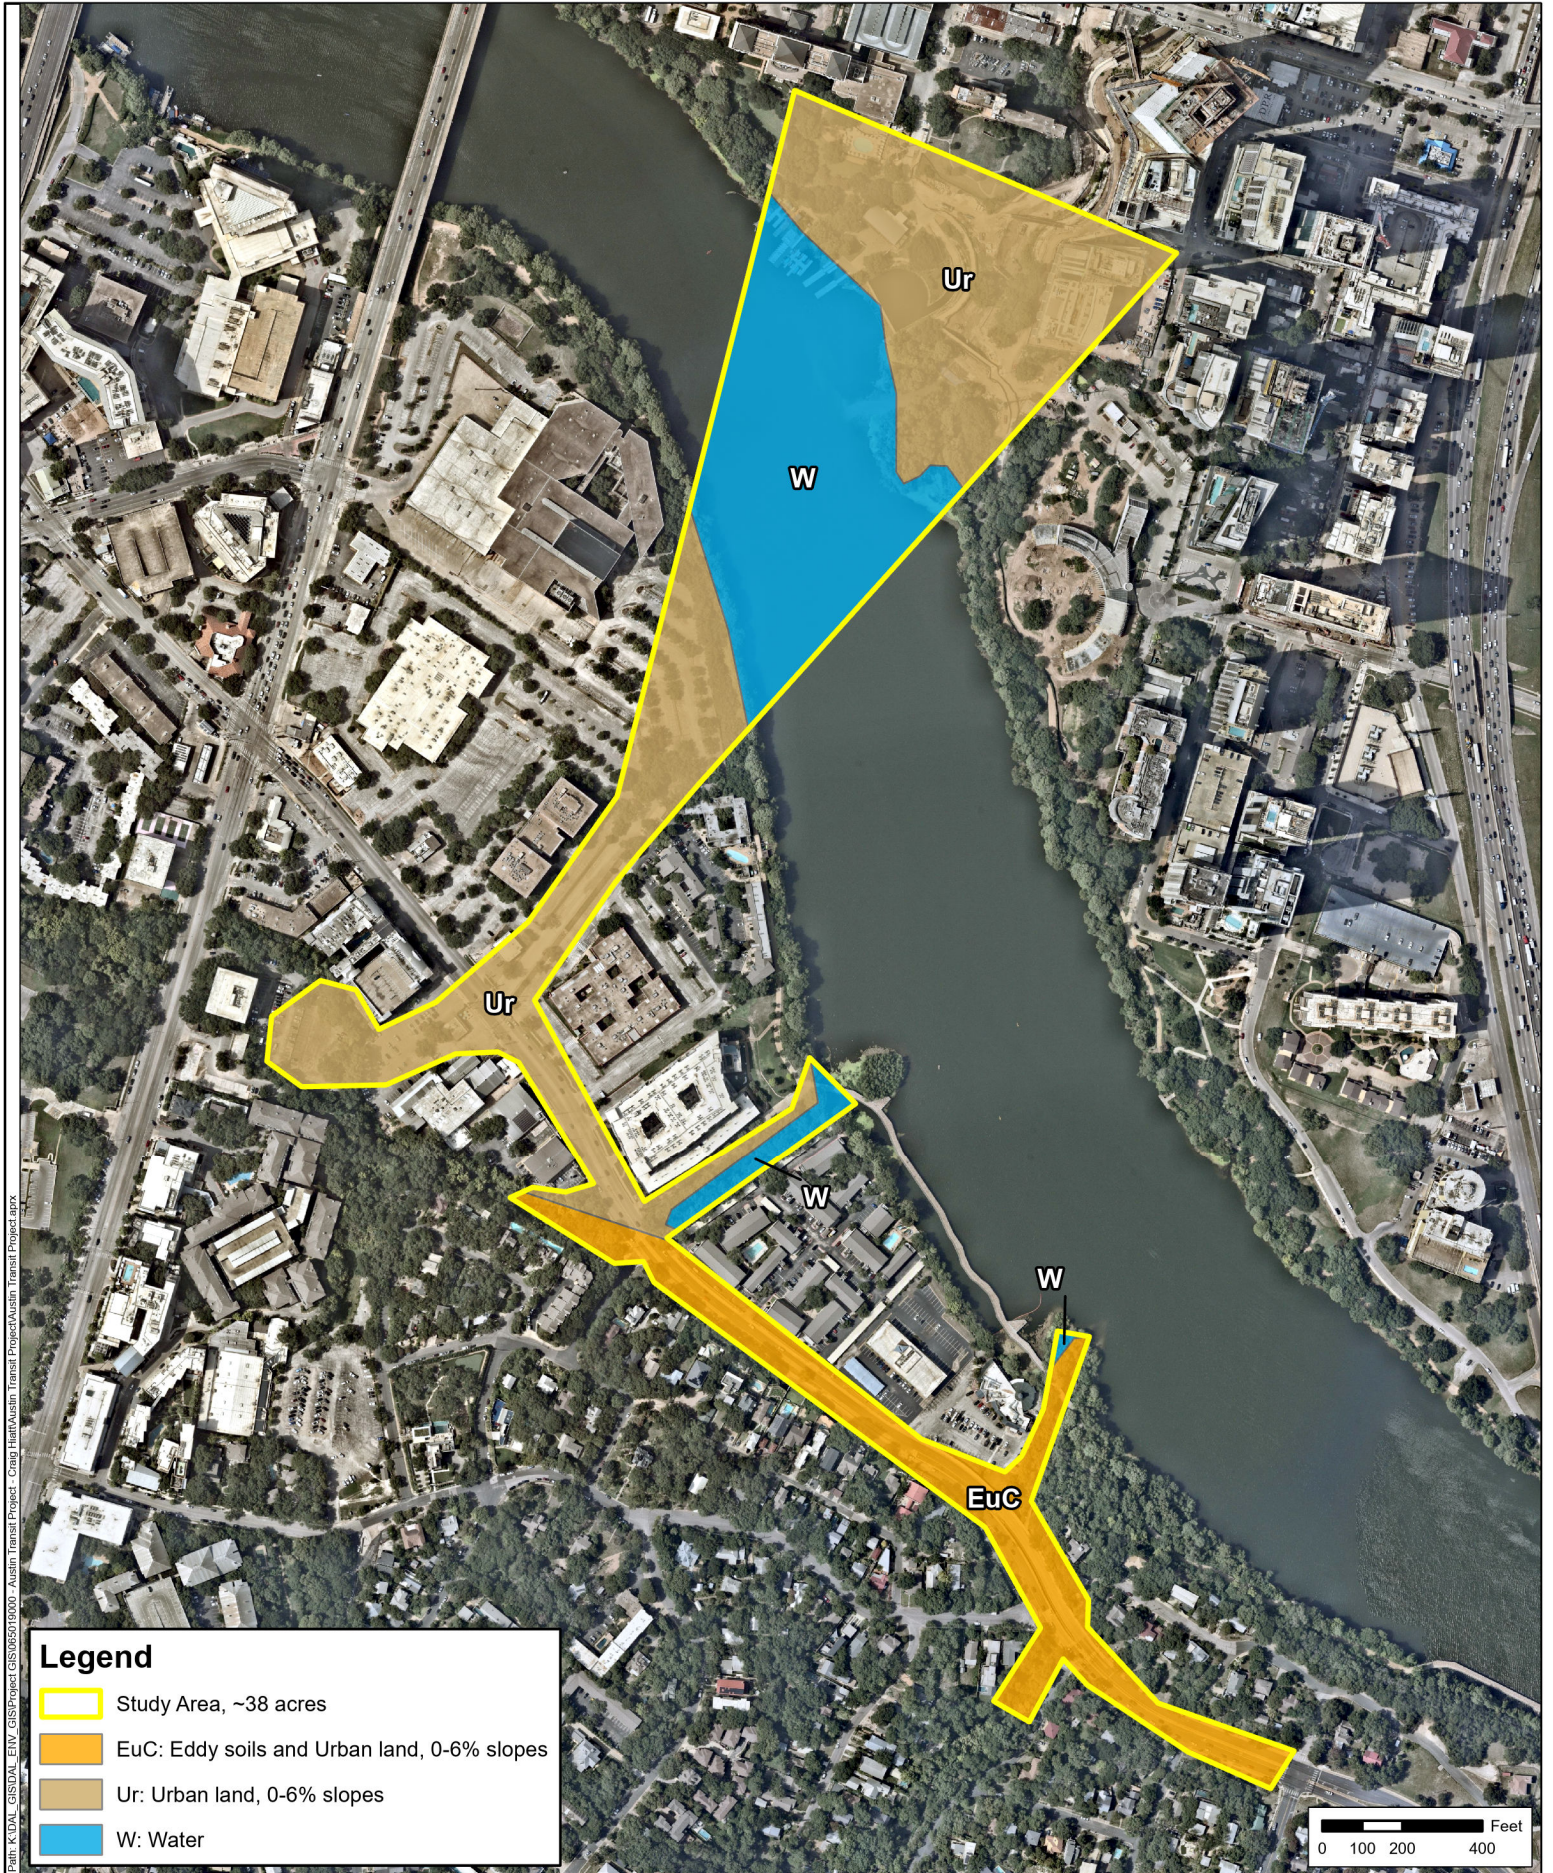
- The NWI dataset is rarely updated.
- Figure 9: Soils Map
 - The U.S. Department of Agriculture (USDA) Web Soil Survey was utilized to download soils data to generate this map.

- Soil maps can be useful in identifying potentially hydric soils typically associated with wetlands.
- Figure 10: Hillshade Map
 - Digital elevation model (DEM) data from the Texas Geographic Information Office (TXGIO) was utilized to generate this map.

Figure 9 in Appendix A depicts the soils overlaid on the study area. Neither of these mapped soil types are located on the Travis County hydric soils list, published by the Natural Resource Conservation Service (NRCS) within the USDA, suggesting wetlands would not be expected. However, six wetlands were observed within the study area.

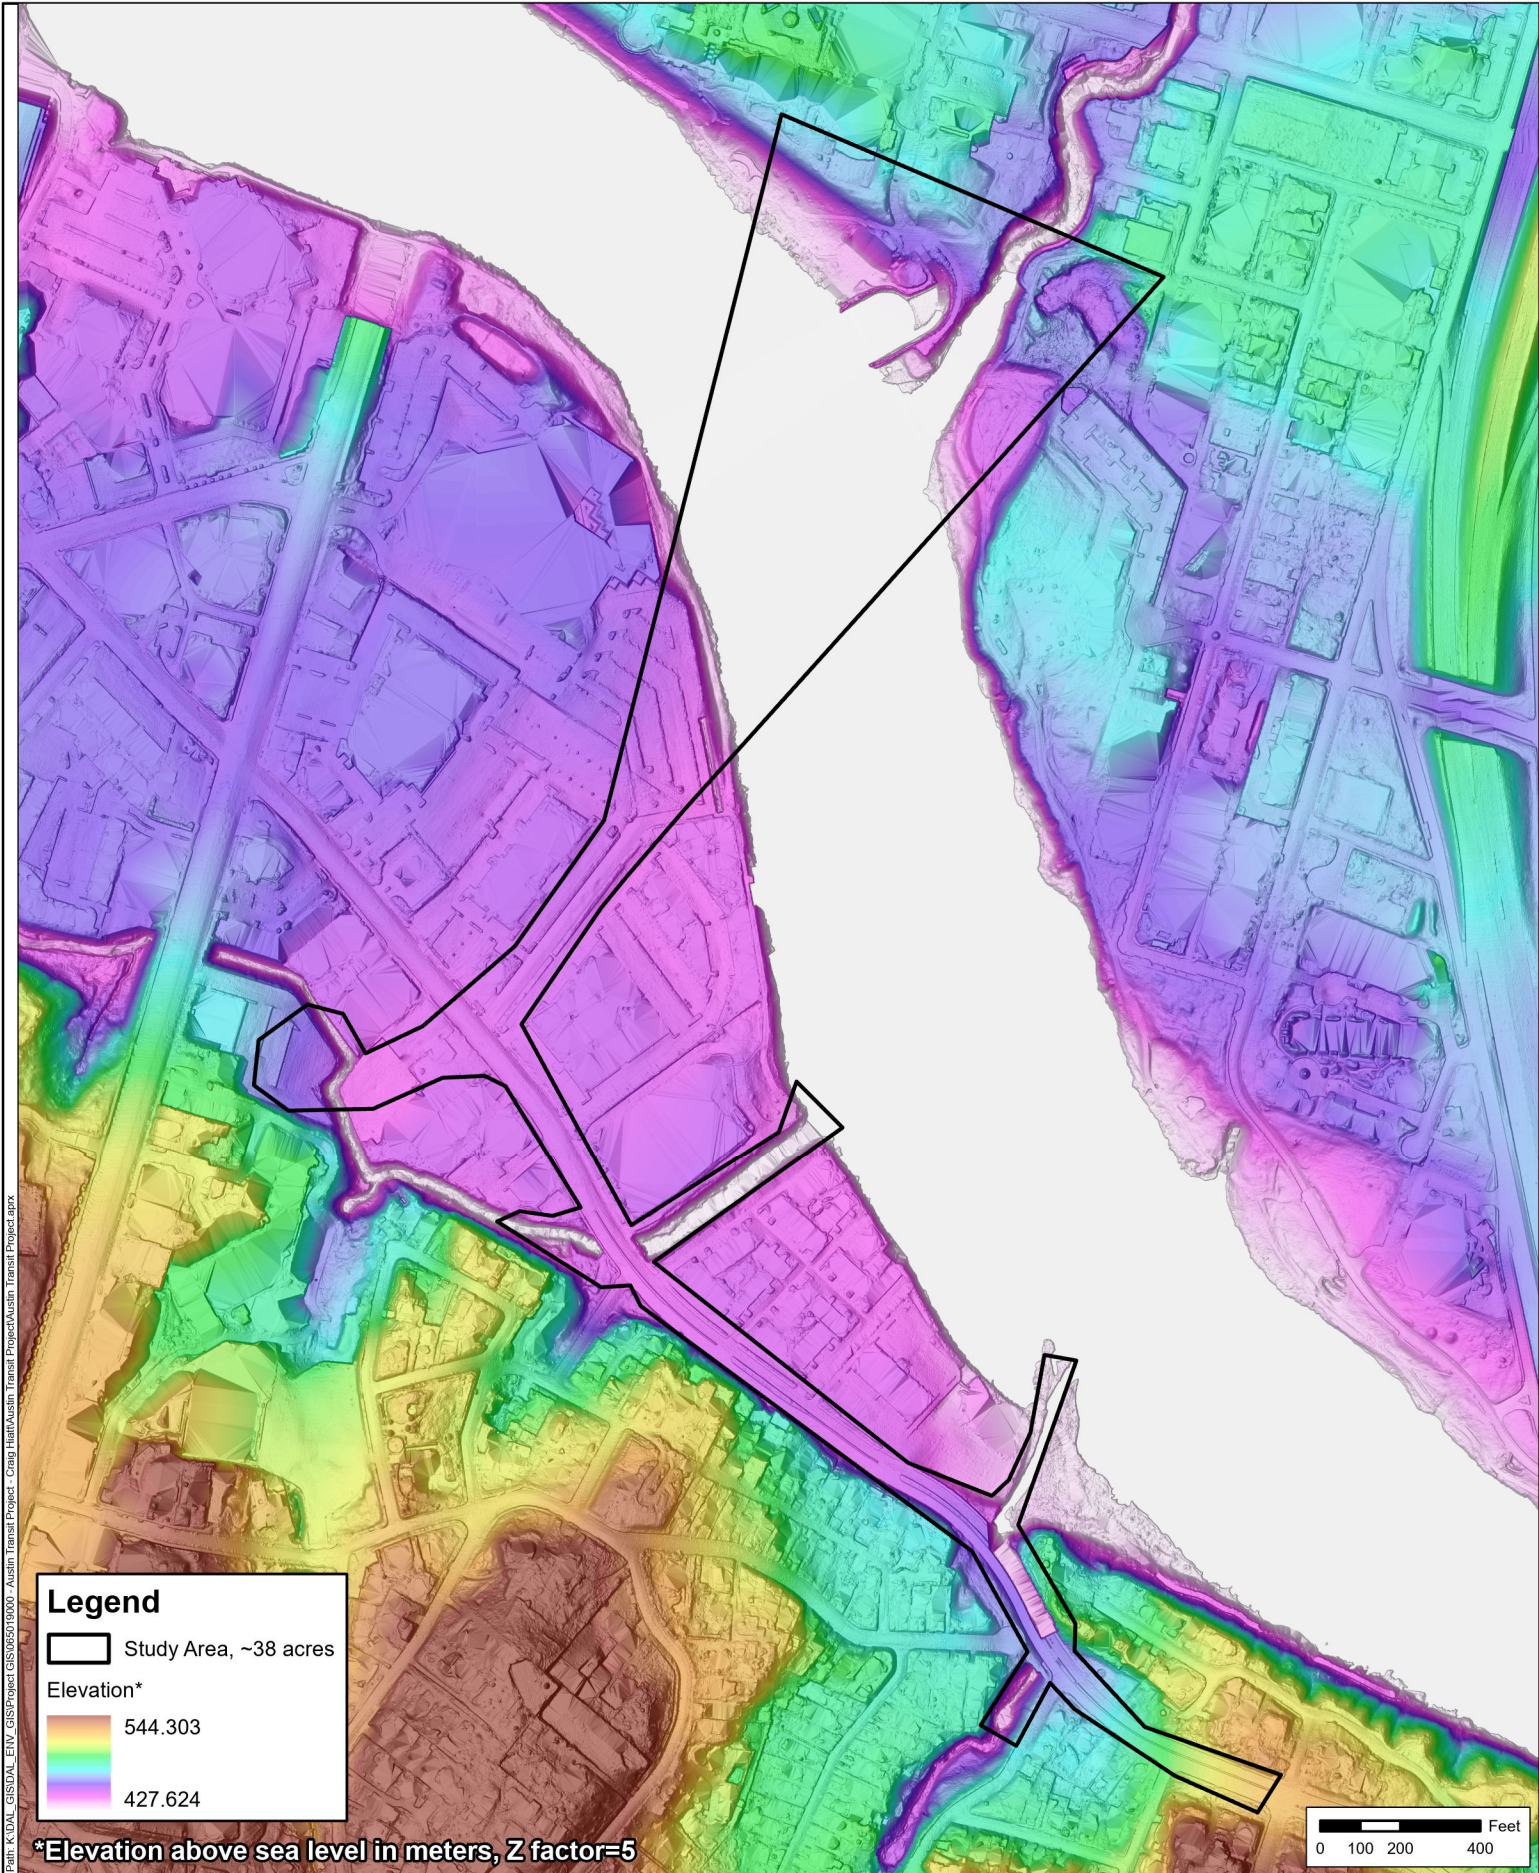
- The land surface appears three-dimensional making low and high areas on the landscape appear easier to distinguish.
- Figures 11.0-11.3: Aquatic Features Maps

- Aquatic feature locations overlaid onto aerial photography from 2024.

-   Study Area, ~38 acres
-   Ephemeral Stream, ~0.07 acre; ~302 linear feet
-   Perennial Stream, ~0.42 acre; ~1,999 linear feet
-   Open Water Features, ~10.3 acres
-   Emergent Wetland, ~0.14 acre
-   Fringe Wetland, ~1.23 acres

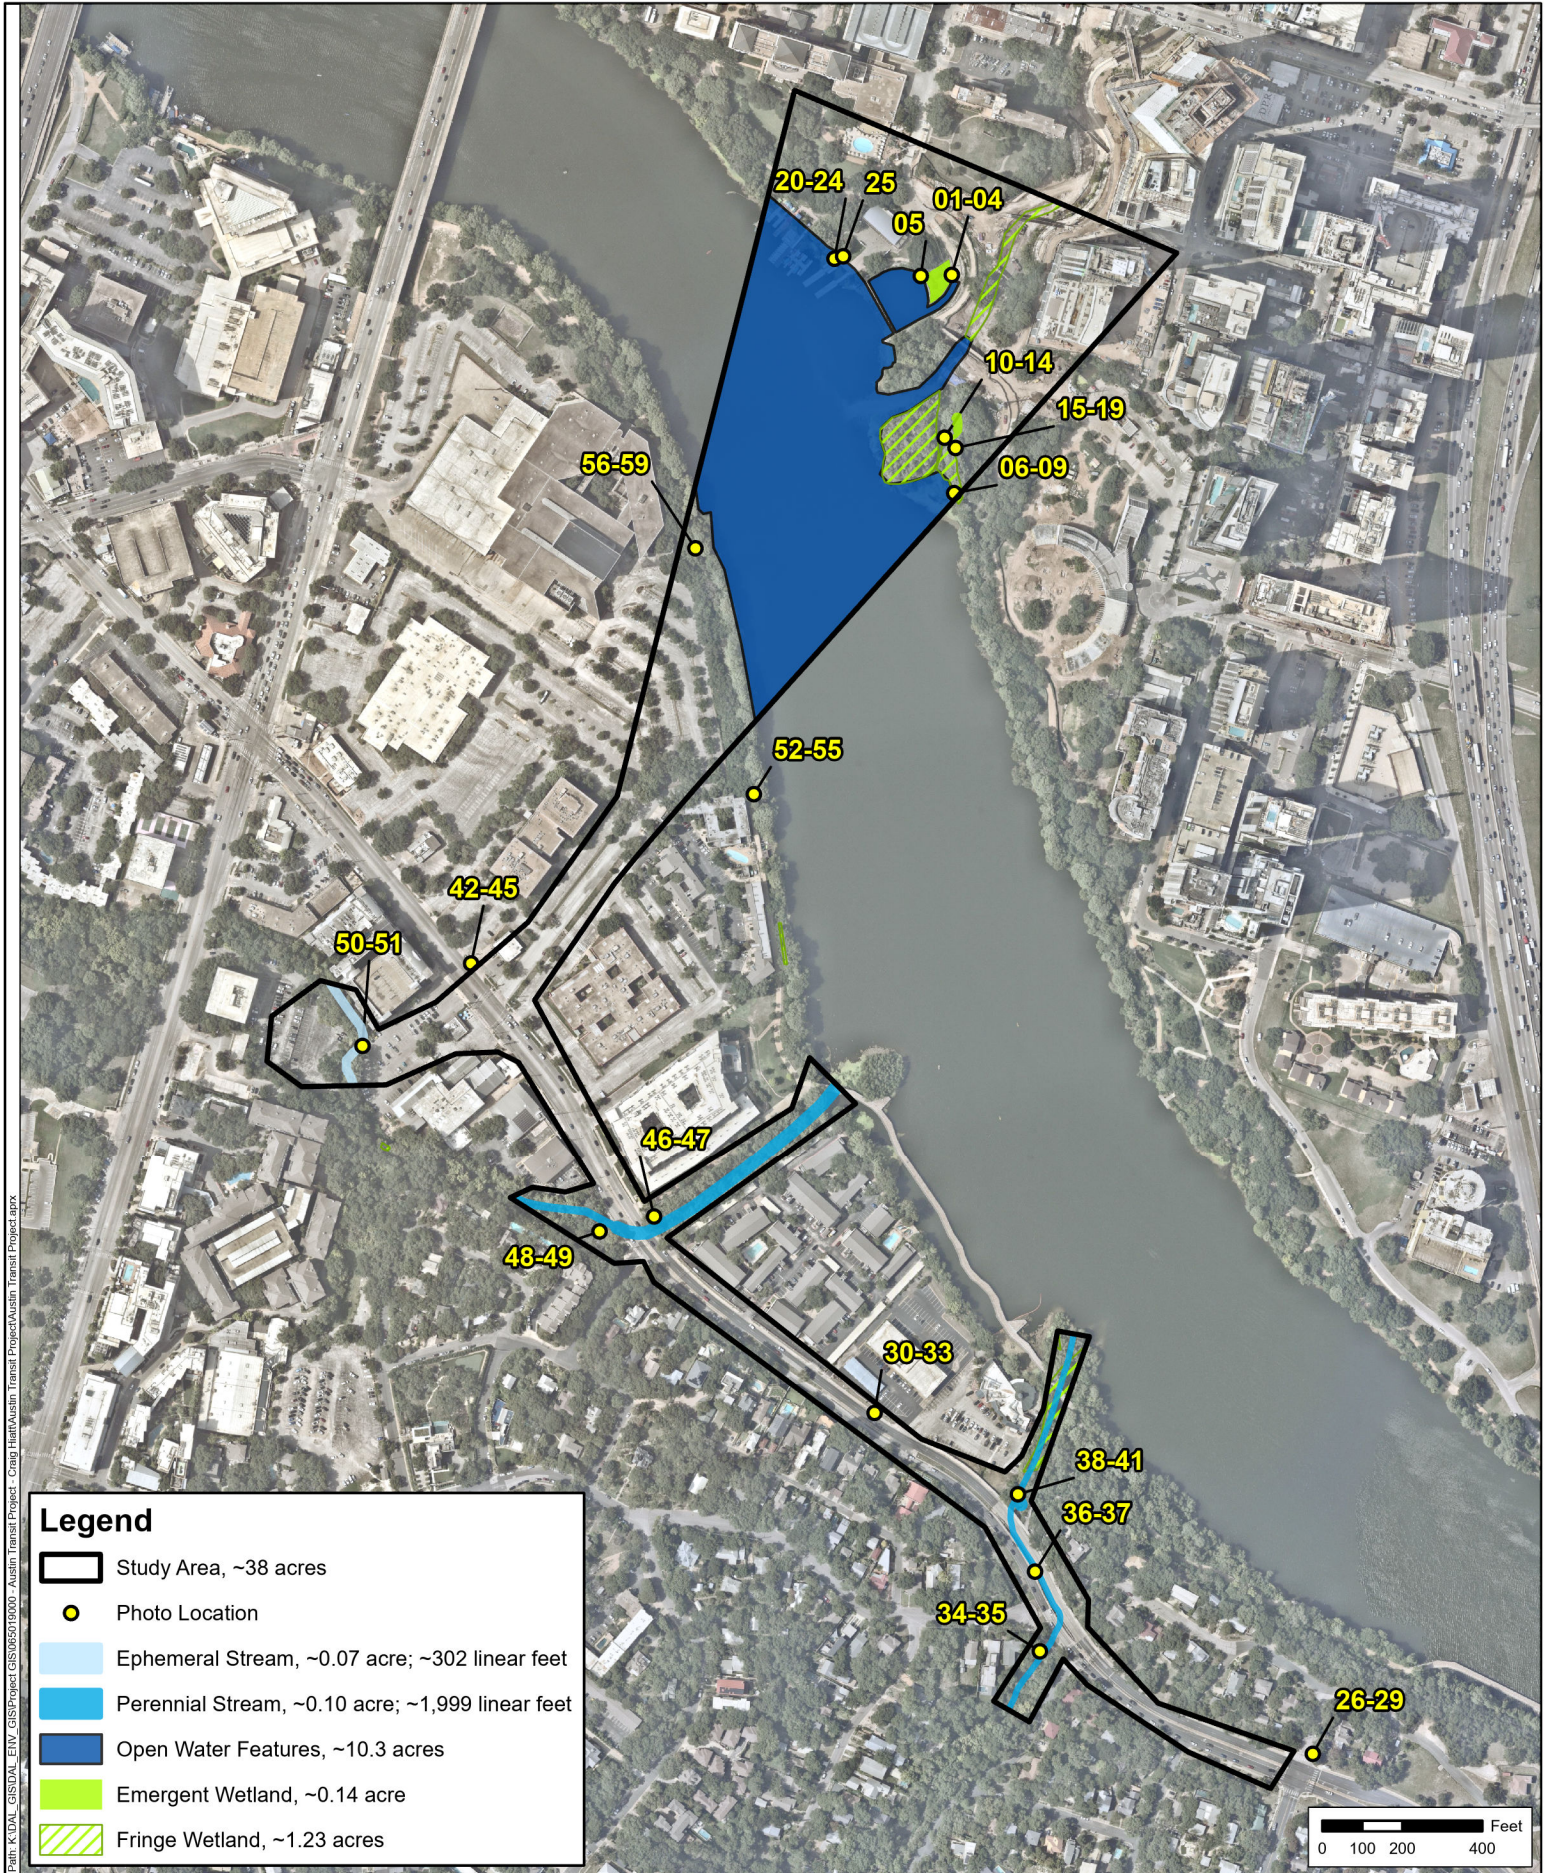
Ground level photographs were taken during the site visit. The general locations of photographs are depicted on Figure 1 in Appendix B and the numbering system on the figure corresponds to the site visit photograph numbers, also included in Appendix B.

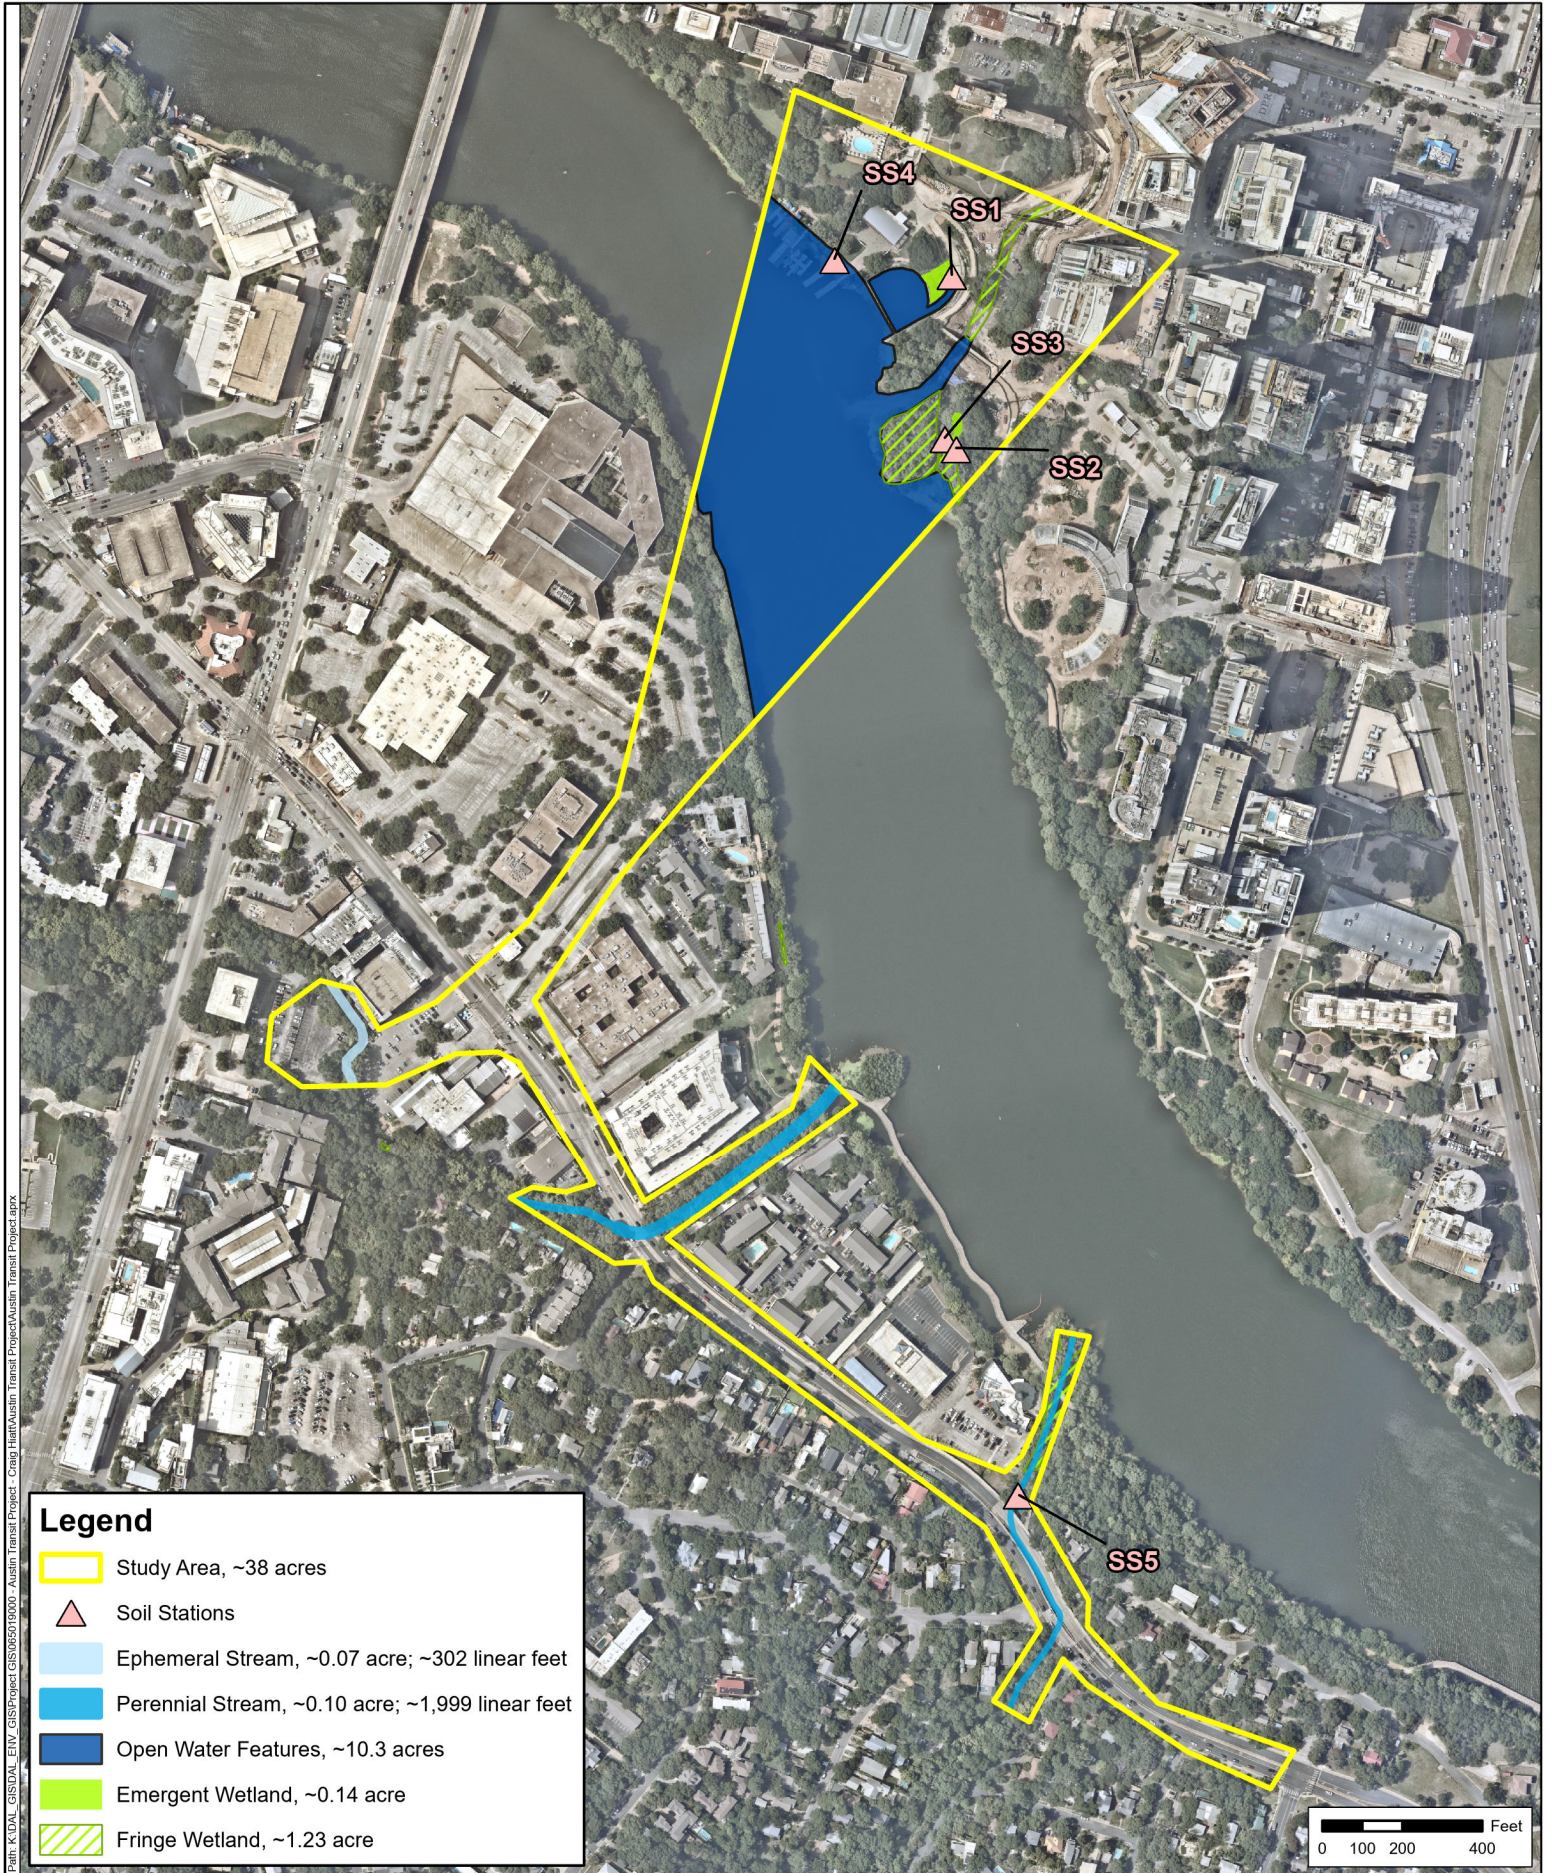
FIGURE 1	DATE: 10/07/2024
	DRAWN: LJK
	CHECKED: KRK
	KHA NO.: 065019000

Wetland determination data was recorded at soil stations during the site visit. The general location of soil stations are depicted on Figure 1 in Appendix C and the numbering system on Figure 1 corresponds to the wetland data determination forms, also included in Appendix C.
